Manhole Inspection Summary

Manhole # S23OO1010MH

Insp Date: **7/11/07 1:13 PM**

Location Address: **4723 FALLS RD**

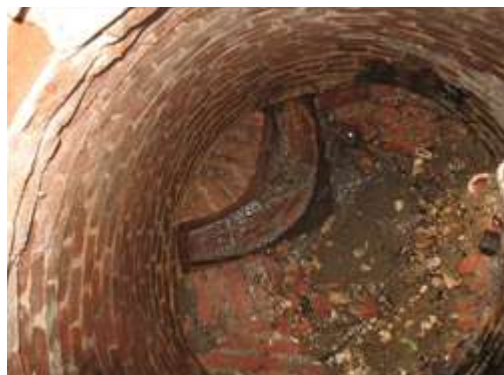
Top View

Evidence of surcharge - Bench debris.

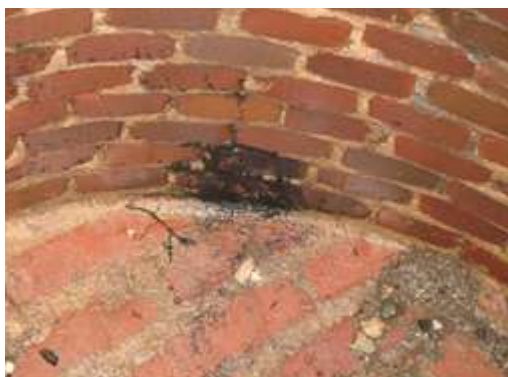
Defect

Barrel infiltration.

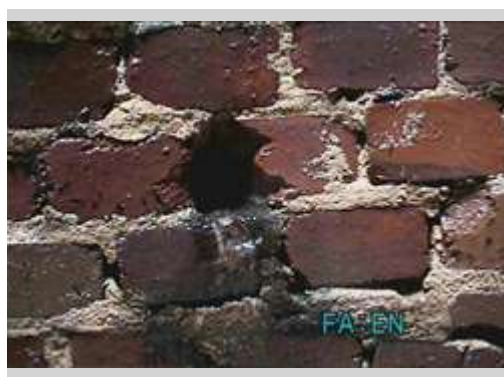
Defect

Comments **HOLE IN BARREL WALL ABOUT 2 GAL. PER MIN. - This MH has active infiltration.**

Barrel deterioration and infiltration (Active).

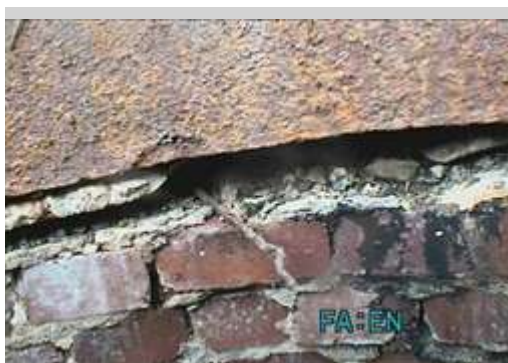
Defect

Frame leaks. Adjustment deterioration, root intrusion and infiltration.

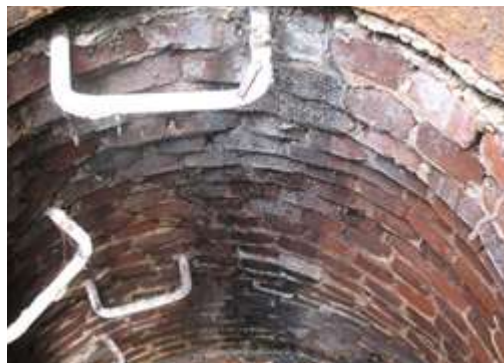
Defect

Frame leaks. Adjustment deterioration and infiltration. Barrel infiltration.

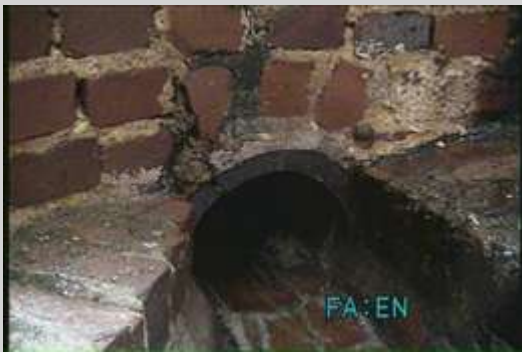
8 in. Circular Gravity Sewer Pipe Out @ 12 O'Clock

Deposits: ☐ None ☐ Mud ☐ Sludge ☐ Debris ☒ Grease

Infiltration: **Evidence** Pipe Seal Cond: **Unknown**

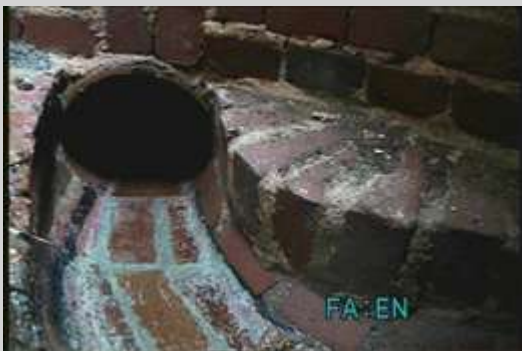
8 in. Circular Gravity Sewer Pipe In @ 9 O'Clock

Barrel deterioration and infiltration.
